STRESS ANALYSIS AND CORROSION FATIGUE TEST OF THE PROPELLER BLADE IN CYCLOIDAL DRIVE

Capt.Swieng Thuanboon, Royal Thai Navy

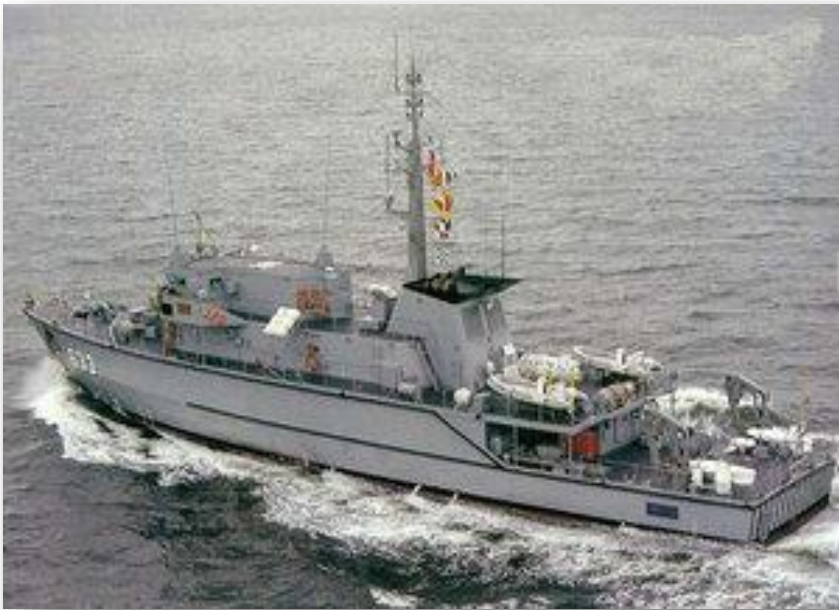
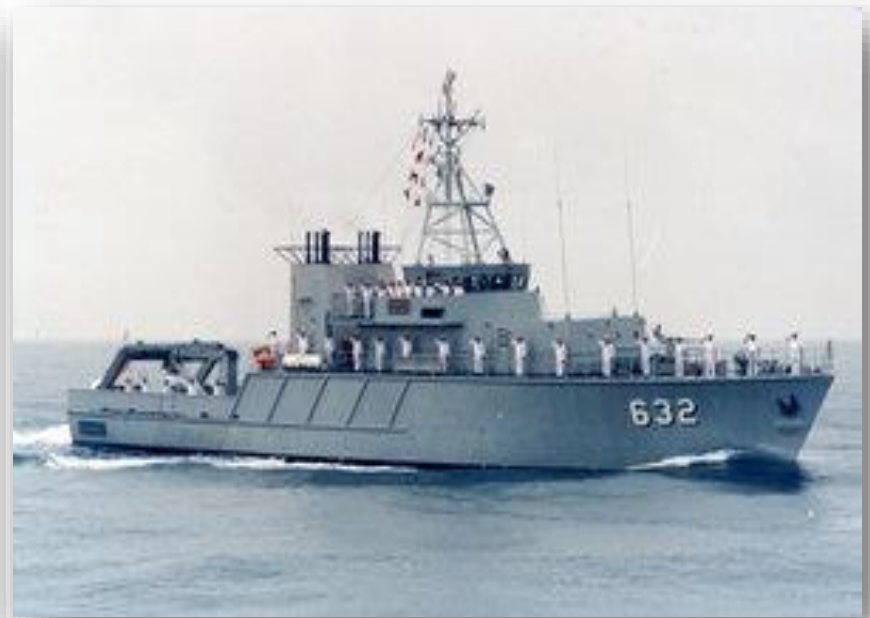
- Vertical drive propellers, or **Voith Schneider**: VSPs in the Navy, are used in Mine Squadron.

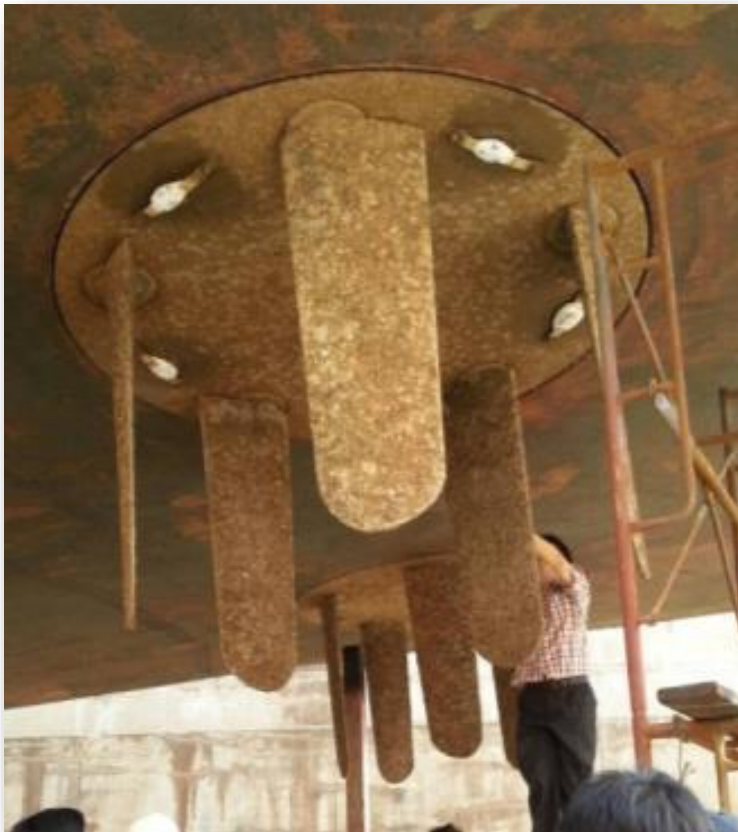
- How Voith Schneider work

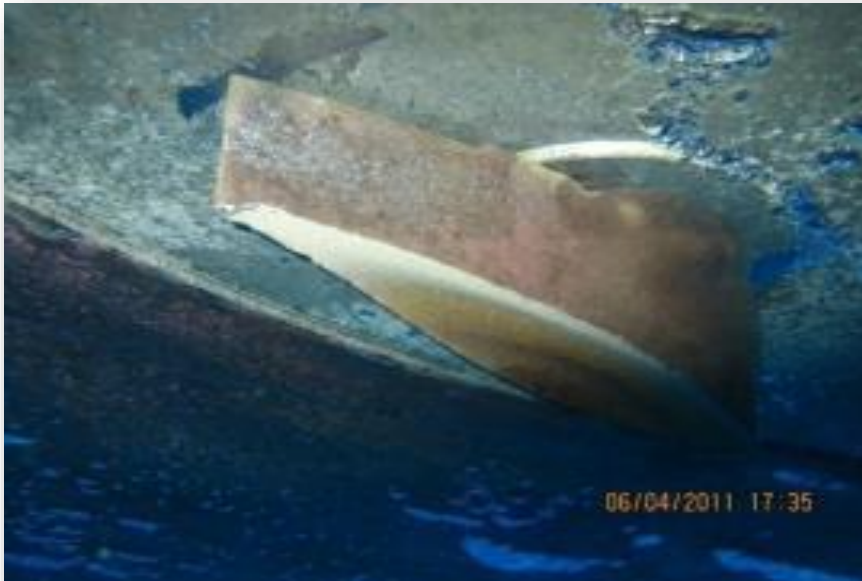
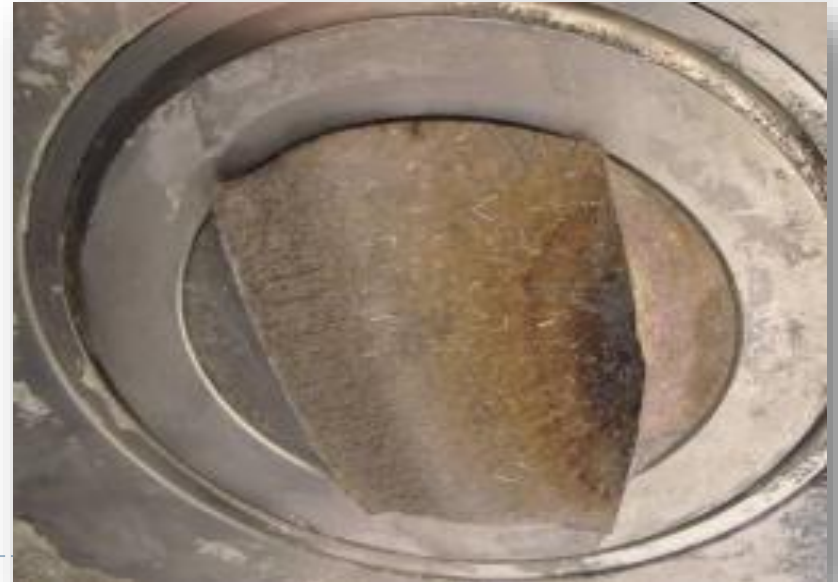
- ▶ The propeller blades were broken regularly causing the navy to lose a lot of budget. Because it must be imported from foreign countries

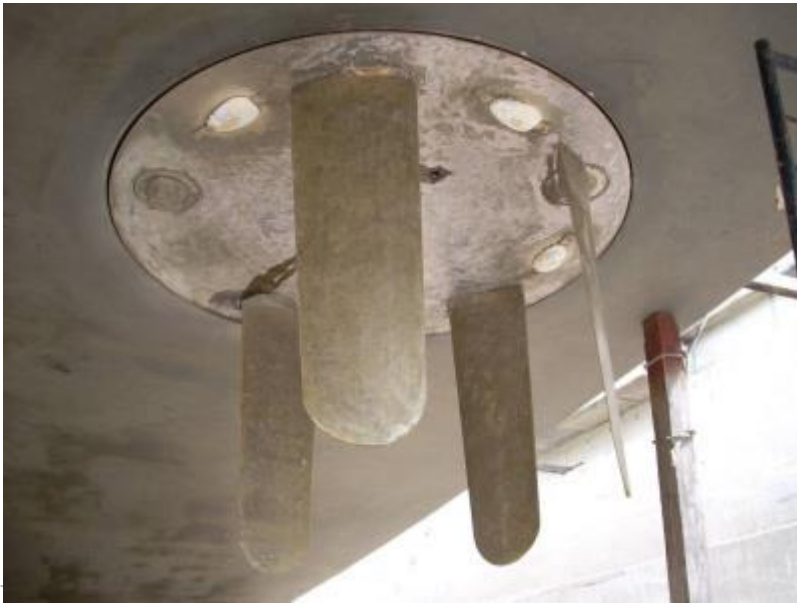
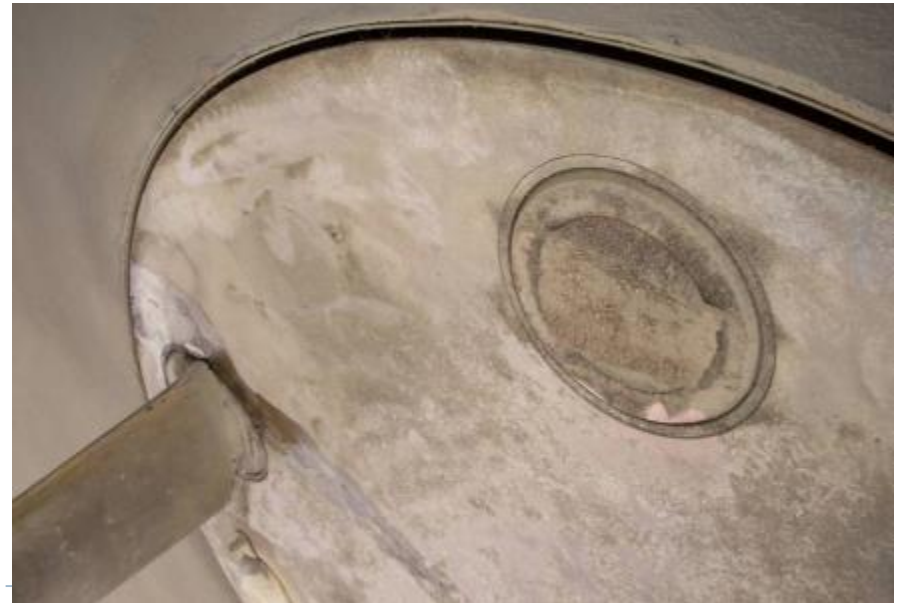
- ▶ Failure analysis found that the reason for the broken propeller due to many reasons
- ▶ The main cause is **Corrosion Fatigue** which is caused by loss of aluminum

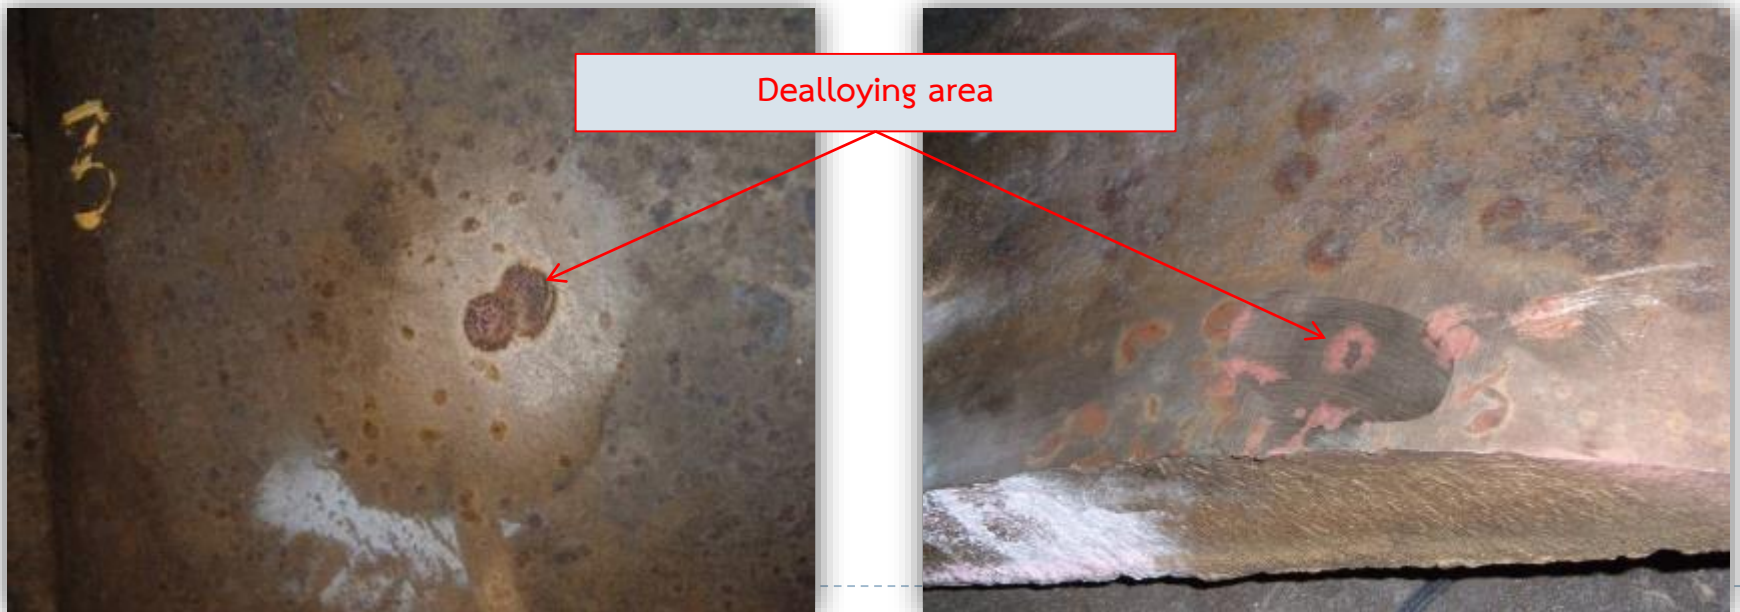
- Propeller material is **Cu-8Al-8Mn-1.5Ni-2Fe**
- ▶ Corrosion due to loss of aluminum (De-alloying) causing the strength of the propeller to be reduced

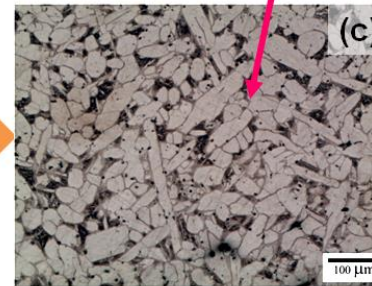
Broken propeller

เฟส	บริเวณที่เกิดการกัดกร่อนแบบสูญเสียธาตุ			บริเวณโลหะเดิม			
	Al	Mn	Cu	Al	Mn	Ni	Cu
α	5.91-8.10	8.02-9.35	Bal.	8.34-8.73	8.07-8.63	—	Bal.
β	0.74-1.15	1.30-1.63	Bal.	12.67-14.09	9.77-10.67	3.31-6.07	Bal.

Aluminum at dealloying location reduce

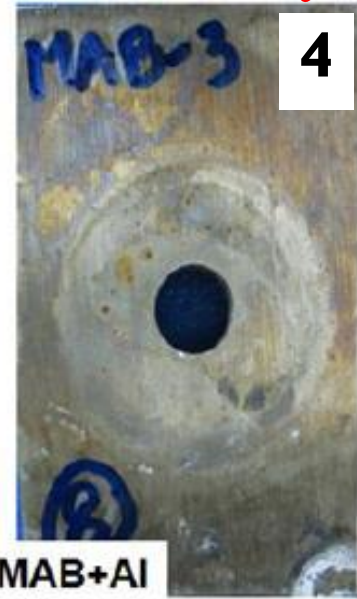
Crevice Cell

- 1) a restricted oxygen supply favors dealloying, particularly stagnant water, crevices and porous surface films
- 2) chlorides, especially in salt water, cause dealloying
- 3) dealloying appears favored by acidity, although it can also occur in alkaline situations
- 4) environments which favor the presence of Cu ions may induce dealloying. These include surface deposits, stagnant flow conditions and crevices or pits
- 5) surface residual stresses, differential aeration or contact with more noble metals may cause anodic behavior and accelerate dealloying corrosion
- 6) dealloying may be prevented in certain alloy systems, including Al bronze, by cathodic protection with Zn anodes or contact with less noble metals such as steel
- 7) dealloying reactions increase with temperature.

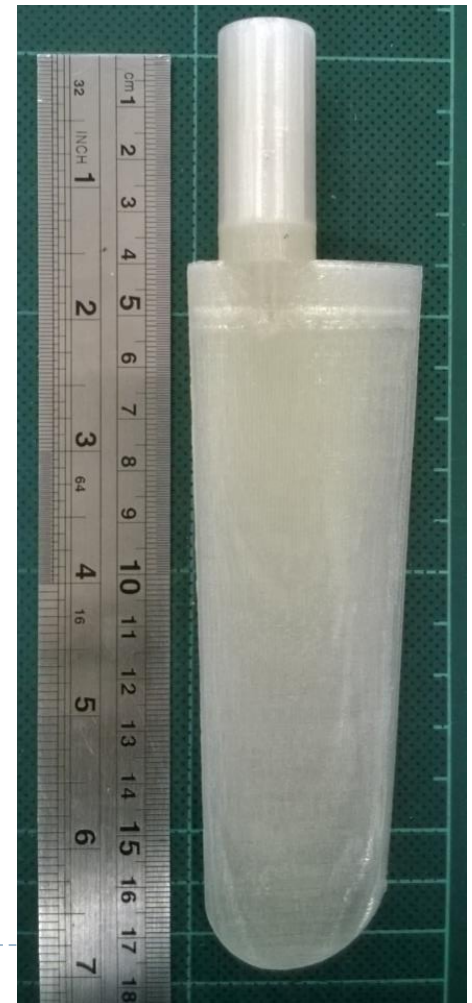
- ▶ Model propeller size 1:10
- ▶ Material Thermoplastic Polylactic Acid (PLA)
- ▶ Rapid Prototype forming
- ▶ To simulate the work of the VSP propeller

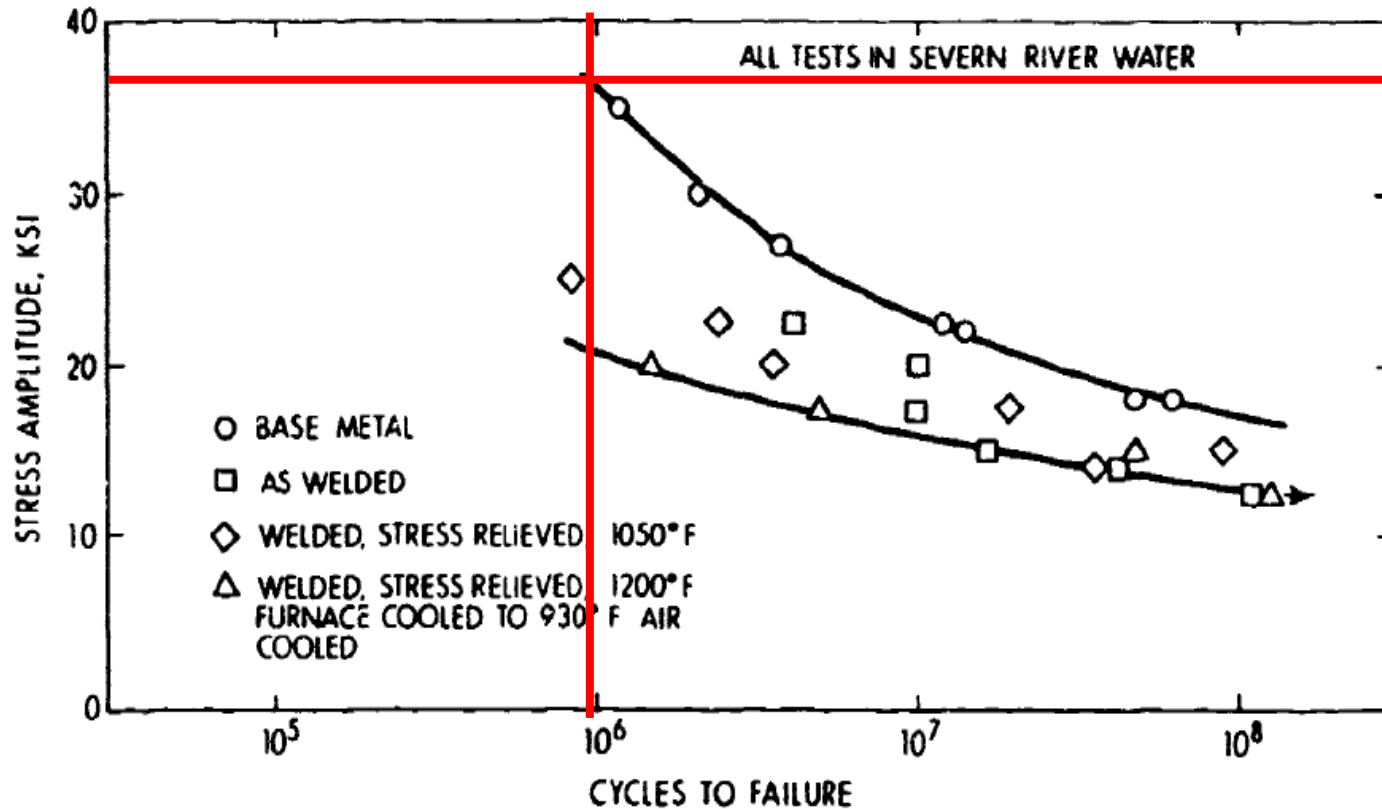
Rotational Fatigue load setup: 36.5 KSI = 251.631 Mpa
