Recommendations for New Rail Inspection and Storage

Keywords: Rail inspection, Rail storage, Decarburization, Standardization

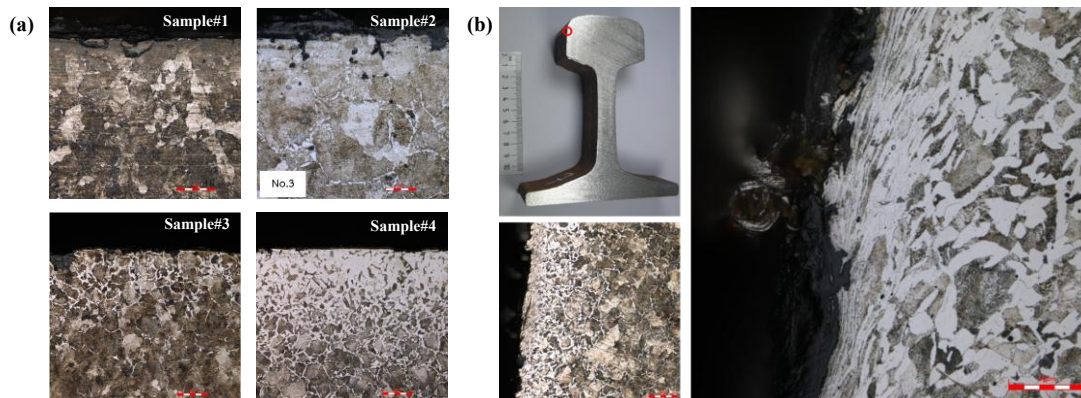
(a) Micrograph of a new rail showing corrosion attack and a decarburized zone with pro-eutectoid ferrite at the surface; (b) rolling contact fatigue cracking associated with the decarburized layer on the running surface after only 8 months in service. These results underscore the importance of sampling inspections of new steel rails to ensure long-term reliability and operational safety.

This study emphasizes the need for standardized acceptance and inspection procedures for new rails in Thailand. Metallurgical analyses of unused rails revealed that additional inspection requirements are essential to ensure safety and service life. Recommended procedures include microstructural examination of the running surface and cross-section, hardness profiling across the rail head, chemical composition analysis, and assessment of decarburization depth.
