Plenary Lectures

Bridging Science and Industry: Data-Driven Strategies for Reliable Operation in High-Corrosivity Environments

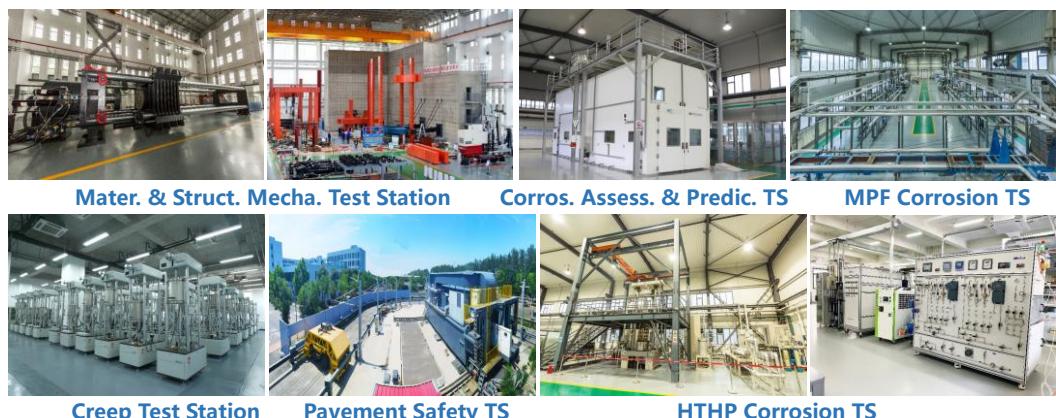
Graphical Abstract

First, a brief introduction to the major national scientific research infrastructure - the Materials Service Safety Assessment Facility (MSAF, with an investment of 505.1 million yuan) is provided. This facility is a large-scale, coupled, extreme and serialized group of test facilities composed of six major test facilities and their supporting simulation and shared systems, which can reproduce the typical failure forms of materials to large/full-scale components/equipment in key industries. Among MSAF, the Corrosion Assessment and Prediction research group (CAPLab) has constructed a set of Atmospheric Environment Test Facility for Engineering Structures (AETFES) with the coupled control of seven environmental factors. In addition, it has accumulated multi-scale experimental evaluation, sensor and monitoring system development, modeling and simulation, as well as the prediction capabilities for the performance of materials/components/equipment. Relying on the national major scientific infrastructure, the CAPLab has provided support to various industries for the safe service and life extension of those key equipment. It has undertaken and completed high-quality reliability evaluation and life prediction of important equipment/key components in complex/extreme working conditions in key areas such as neutron absorption equipment for wet storage of spent nuclear fuel in nuclear power plants, dry storage tanks, high-pressure hydrogen transmission pipelines, and the hydrogen fuel system of the main torch for the 2022 Beijing Winter Olympics, etc.

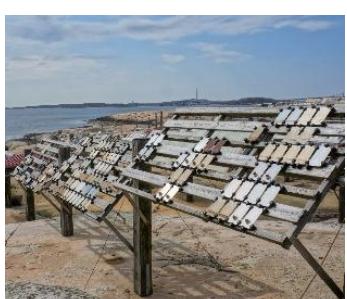
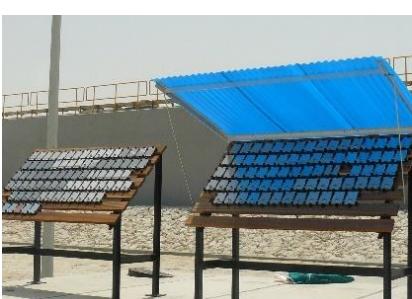
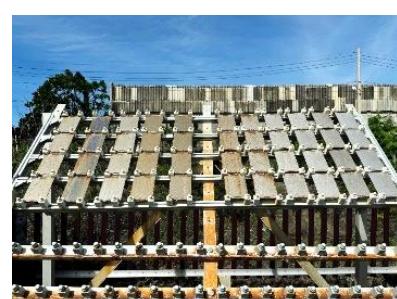
International standards and guidelines, including ISO 9223, EN 1993-1-4 Annex A (Eurocode 3), the IMO A Site and Design Evaluation System tool (IMO A program), and a Corrosion Map, establish frameworks for material selection in structural applications. While these guidelines aim to simplify the material selection process and minimize testing duration, they must accurately depict the behavior of stainless steel under real-world environmental conditions. This study presents the findings from various field investigations into atmospheric corrosion in maritime coastal regions characterized by diverse climates: (1) Bohus-Malmö, Sweden; (2) Dubai, United Arab Emirates (UAE); and (3) Songkhla, Thailand. The selection of suitable material grades in these environments must align with performance requirements. The results underscore the considerable impact of environmental factors, particularly chloride ions, contamination, and rainfall, on localized corrosion and surface degradation. These findings are examined in the light of current understanding regarding the atmospheric corrosion of stainless steel, offering valuable insights for practical applications in the field.

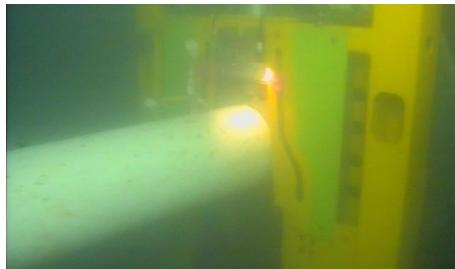
Nautilus deployment commenced as planned. The landing of Nautilus was carried out by the vessel crane. Nautilus was landed on the pipeline within the marked area observed by the ROV. The landing on the pipeline within the marked area was carried out efficiently.

Fig. 16—Nautilus landed on the marked area of the pipeline

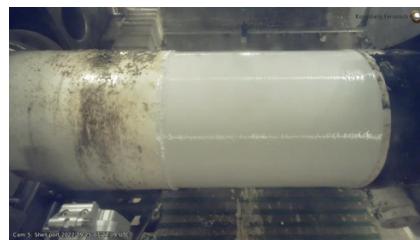
Conclusion: Coating application completed. Coating has good coverage over the repair area according to procedure. All pipe bare steel sections in the repair areas are covered with coating. Nautilus can proceed to the next step, which is curing of coating, and followed by leak repair application.

Fig. 19—Coated repair area

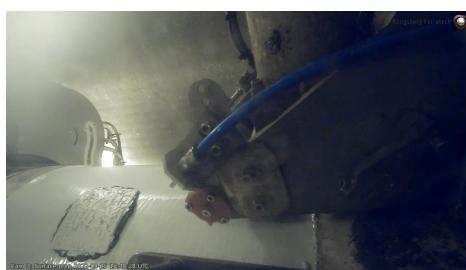
Conclusion: Adhesive and patch applied over the defect correctly according to program. Heat treatment of the adhesive for 5 hours is completed. Some excessive adhesives at the edges, which indicates good coverage under the patch. Next step is wrapping application.

Fig. 20—Patch application

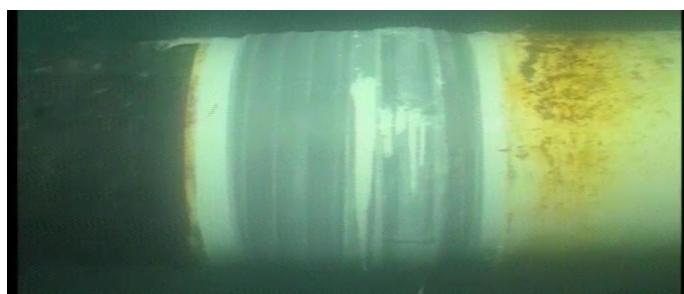
When the composite wrapping had cured for 4 hours, the tension was released. Thereafter, habitat was refilled with water, followed by opening of the shells. ROV hook reconnected to the Nautilus master link, and the Nautilus was then retrieved back to the vessel after a successful operation.

Fig. 22—Finished repair post Nautilus retrieval.
